City of Alexandria Storm Sewer Capacity Analysis (CASSCA)

Potomac River Condition Assessment

PREPARED BY: Michael Baker Jr., Inc.

DATE: January 12, 2015 (Revised May 26, 2015)

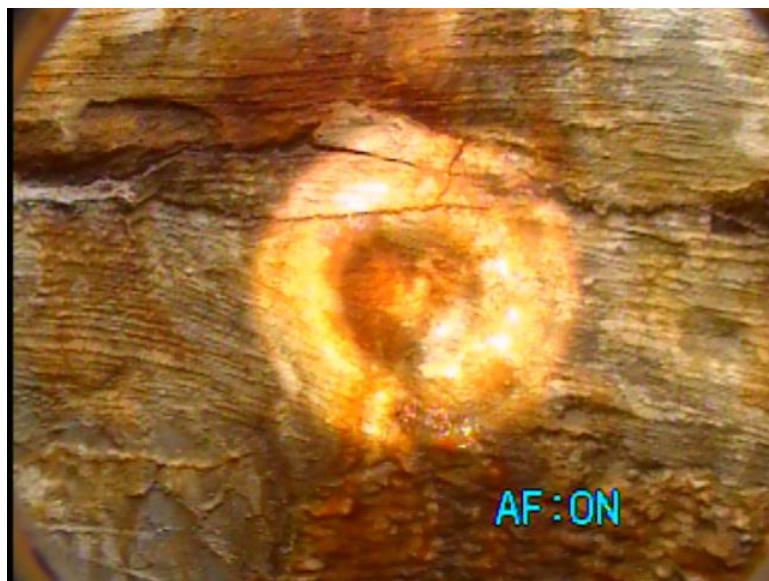
**Figure 4. Moderate Damage to Chamber Wall in Structure 001925SMH
(Overall SCREAM Score = 65).**

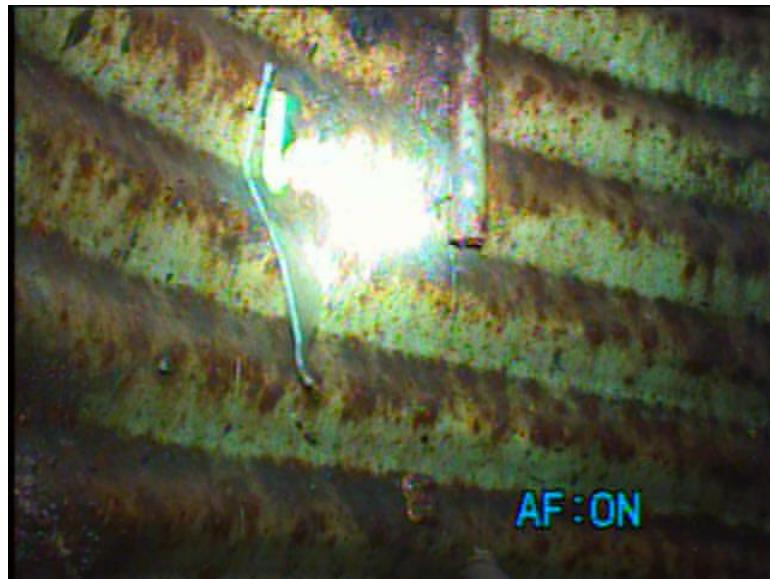
**Figure 5. Damage to Chimney in Structure 002437SMH
(Overall SCREAM Score = 70).**

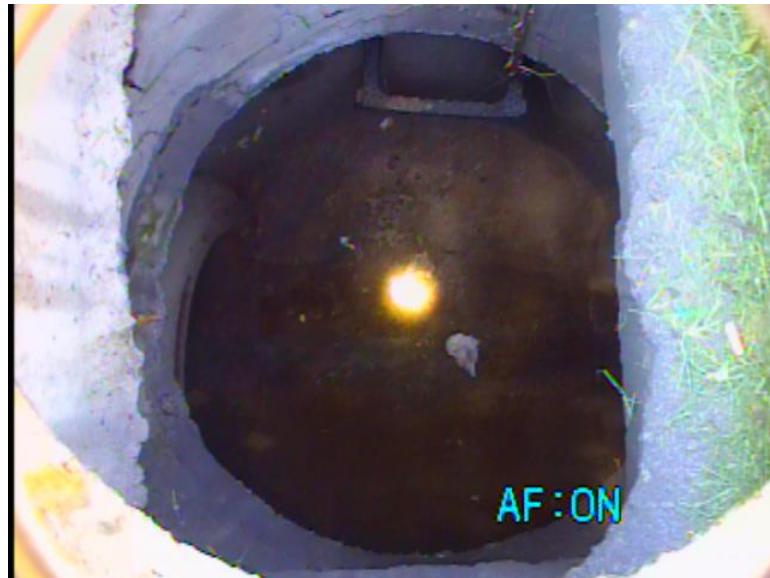
**Figure 6. Moderate Damage to Frame Base Seal in Structure 008168IN
(Overall SCREAM Score = 56).**

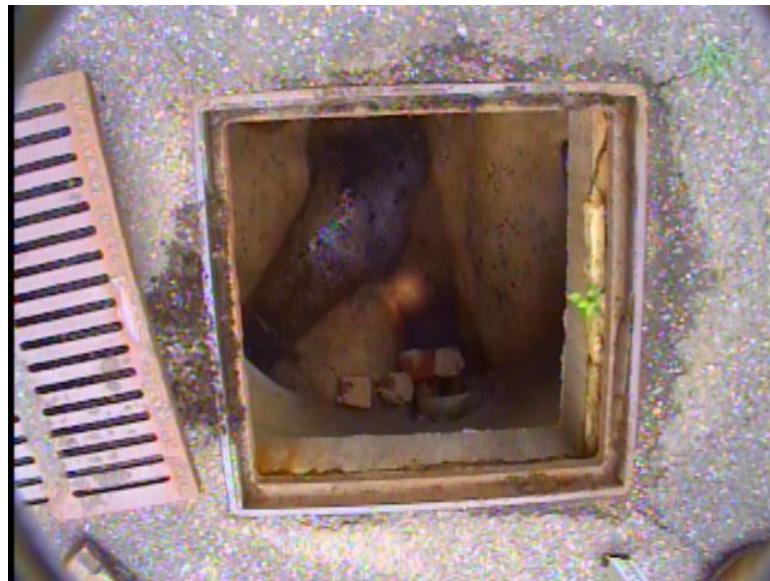
Examples of problems in the major category for the frame base seal and frame are shown in Figures 7 and 8, respectively.

**Figure 7. Major Frame Base Seal Damage on Structure 008281IN
(Overall SCREAM Score = 78).**

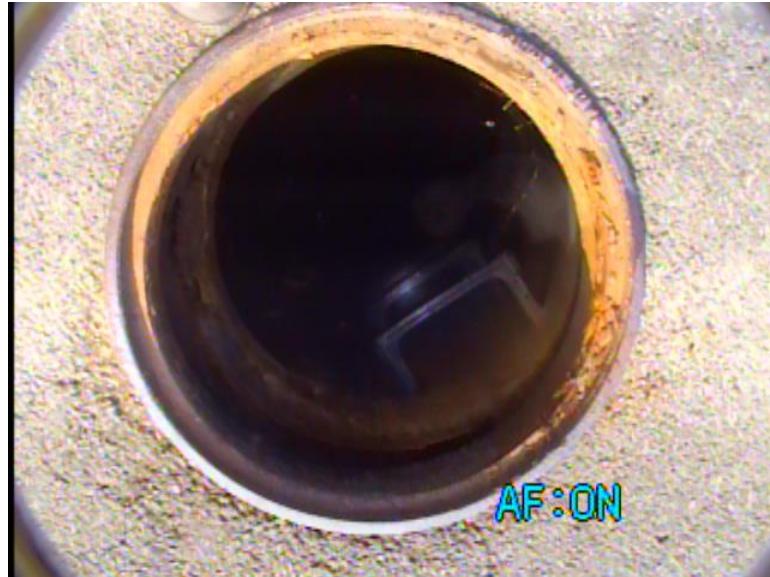
**Figure 8. Major Frame Damage (Offset) on Structure 001902SMH
(Overall SCREAM Score = 73).**

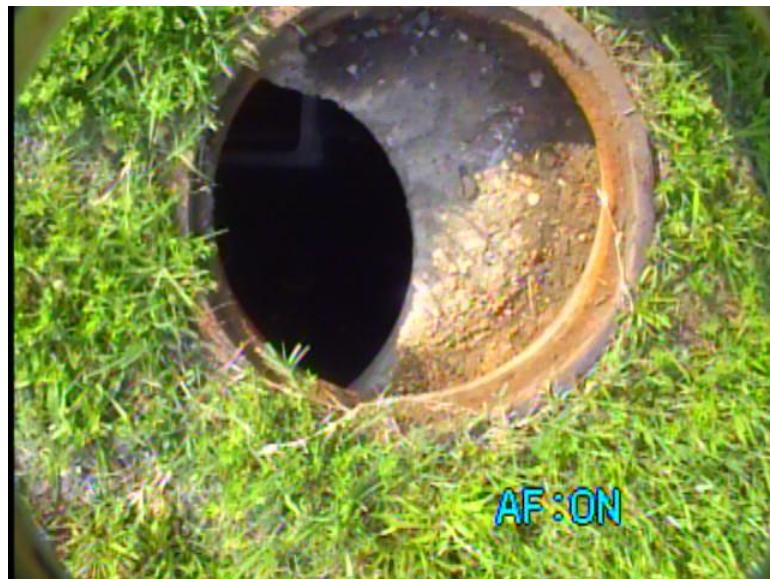
material loss). Infiltration associated with the cracks (inflow higher than about 10 gpm) is also ranked in the extreme category of defects. Figures 9, 10, and 11 are examples of problems in the extreme category associated with the frame, frame base seal, and channel, respectively.

**Figure 9. Offset Frame in Structure 001892SMH
(Overall SCREAM Score = 75).**

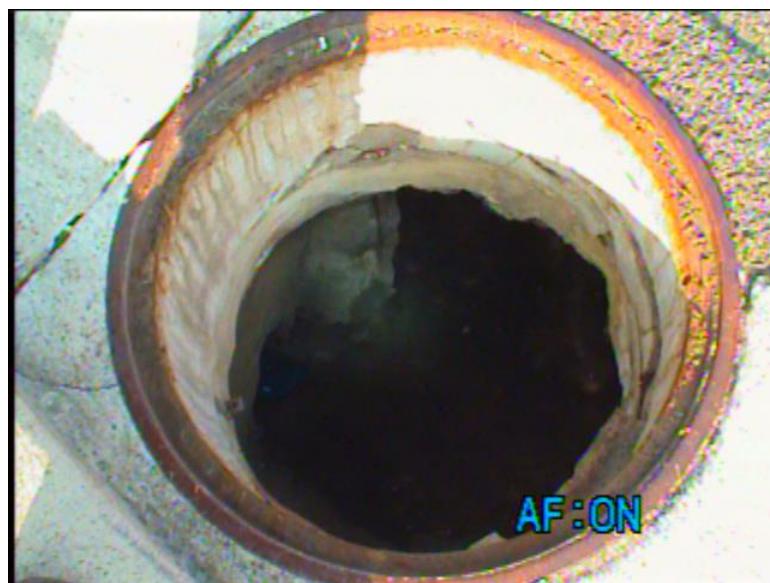
**Figure 10. Extreme Frame Base Seal Damage in Structure 002448SMH
(Overall SCREAM Score = 76).**

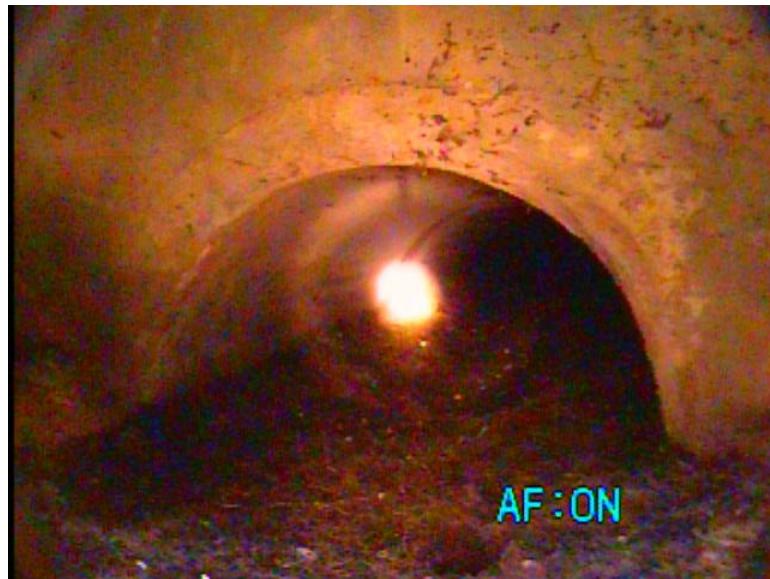
**Figure 11. Heavy Debris in Structure 002445SMH
(Overall SCREAM Score = 72).**

Chamber	I/I evidence	Min: <1/4gpm, staining, mineral deposits, flow weeping		I/I							
				Channel	Debris/deposition	Extreme: >5 gal bucket		Maintenance							
Potomac	002445SMH	X	916	PORTNER PL	Sidewalk	08/01/2013	08/01/2013	Truck 1	1		72	50	50	0	2
				Chamber	Cracked	Min: 1/16" to 1/8" (2-3mm) width, chipping, spalling		Structural							
				Chamber	Corroded, pitted, spalled	Min: <10% mat'l loss, etching		Structural							
				Channel	Debris/deposition	Extreme: >5 gal bucket		Maintenance							
				Chimney/Shft	Cracked	Min: 1/16" to 1/8" (2-3mm) width, chipping, spalling		Structural							
				Chimney/Shft	Corroded, pitted, spalled	Min: <10% mat'l loss, etching		Structural							
				Frame Base Seal	Cracked / deteriorated	Min: 1/16" to 1/8" (2-3mm) width, chipping, spalling		Structural							
				Frame Base Seal	Corroded, pitted, spalled	Min: <10% mat'l loss, <3/8" (1cm) etching		Structural

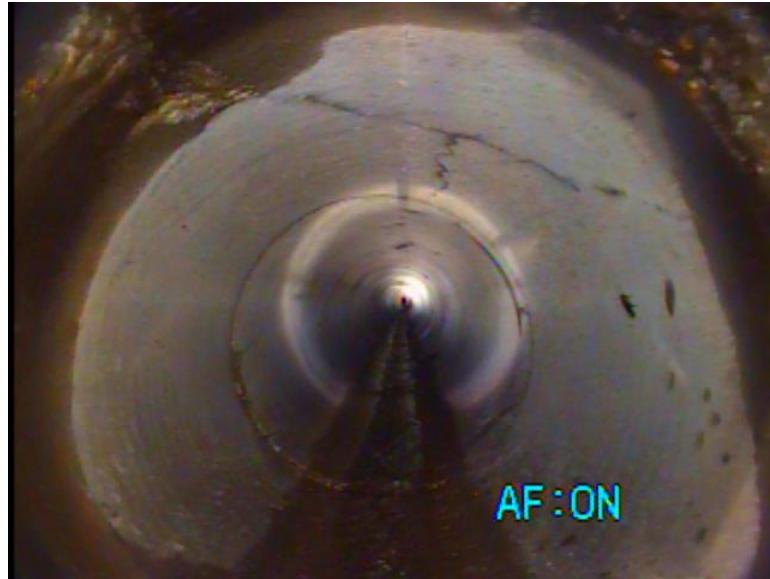
**Figure 14. Infiltration Evidence in 36-in Storm Pipe between Structures 008167IN and 008162IN
(Overall SCREAM Score = 13).**

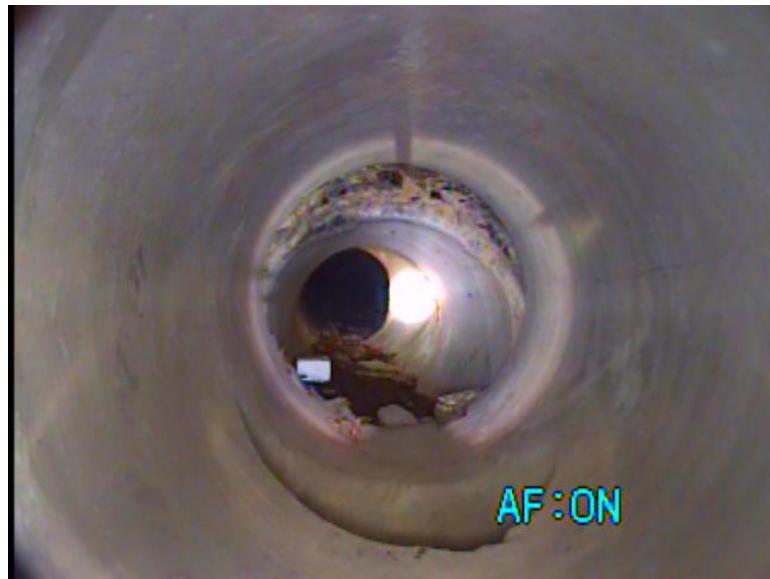
**Figure 15. Displaced 15-in Storm Pipe between Structures 005138IN and 002379SMH
(Overall SCREAM Score = 25).**

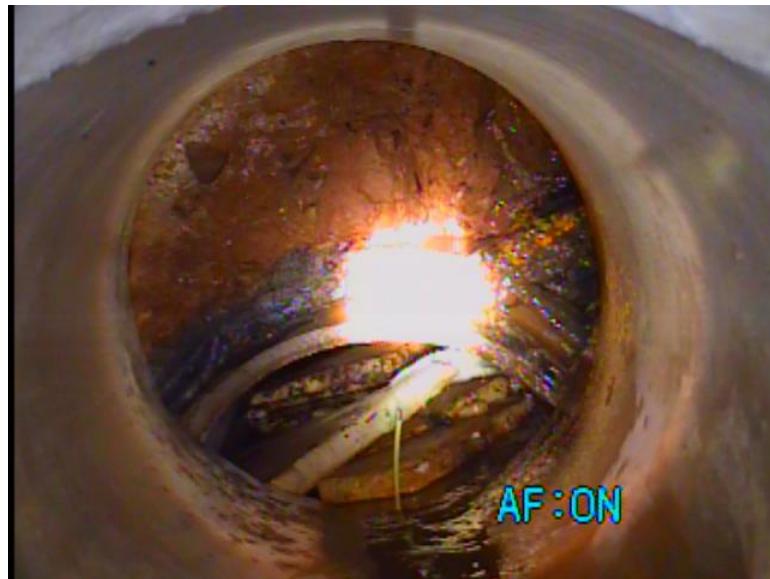
**Figure 16. Collapsed 15-in Storm Pipe between Structures 005137IN and 002379SMH
(Overall SCREAM Score = 100).**
